Safety Advisory #1 – Wheel Plate Bolts

Rev. 1B, Oct. 8, 2016

Affected Models:	All Models, all Serial Numbers
Issue:	Main Landing Gear Failure to Extend
COG Recommendation:	Ensure that your aircraft has the correct wheel Plate hardware and that it is installed correctly as per the IPC. In addition, inspect your rubber stop bumpers for condition.
Purpose:	Eliminate a binding condition that can cause the main gear assembly to hang up and not extend

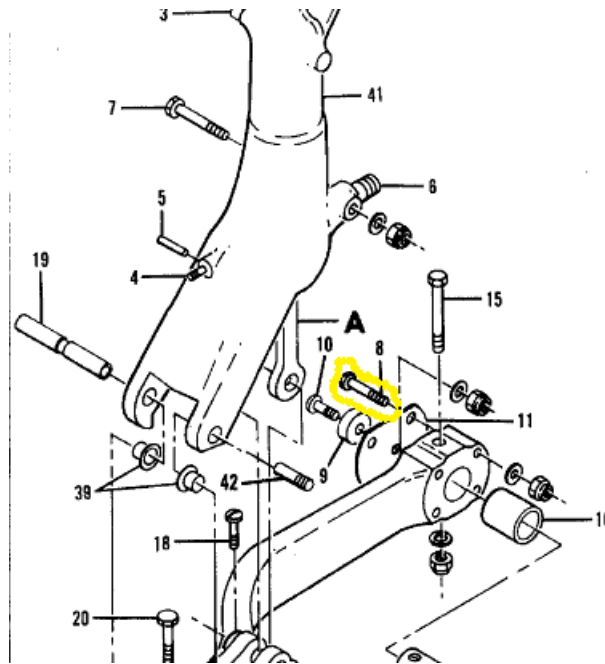
Figure 1

Recently we had an owner experience a main landing gear that failed to extend (downward) as a result of being hung up in the wheel well. The primary cause was determined to be a bolt on the lower landing gear yoke assembly which holds the *Plate* (**Figure 1**; 112/114 IPC 2-15-8, AN5-24A) having been installed backward and the exposed threads then becoming caught on the edge of the Up-Stop Bracket when the gear is in a raised position. (**Figure 2**; *Bracket, MLG Up-Stop pn 42385-3*. **Note: 42385-3 is not shown in 112IPC**)

It is **highly recommended** that as soon as practical, you inspect your main landing gear to insure that the correct length bolts are properly installed with the bolt heads on the same side as the rubber bumper. **Any deviation from the IPC parts specifications and position guidance should be corrected immediately.**

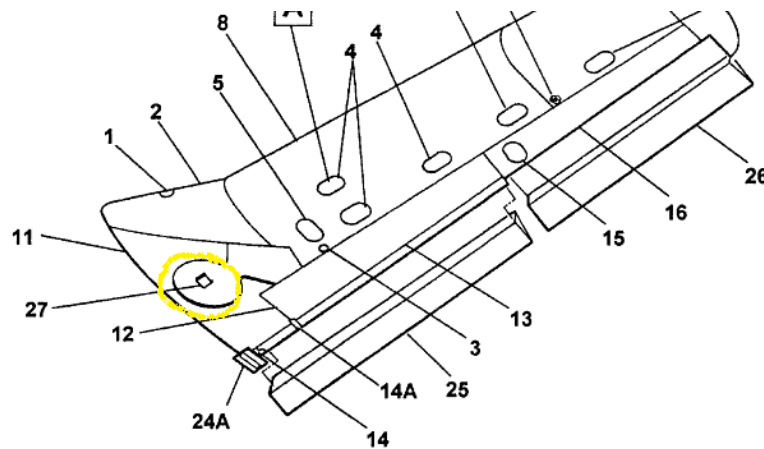
Figure 2

1. Bumper that was worn out and compressed
2. Bolts on the Main Landing gear Yoke assembly fastening the *Plate* (2-15-11, pn 42308-3) being installed in a reversed condition. (Yoke is Item #22 Figure 2-15 in Commander IPC)
3. Incorrect longer bolts installed. (Bolts are Item #8 Figure 2-15 and item #14 or 27, Figure 2-16)
 - a. **Note: the nut specified on the AN5-24A bolt is a thin profile MS20364-524 nut**
4. The *Bracket, MLG Up-Stop* that the bumper contacts in the wheel well has been found to be in slightly different wheel well locations on each plane due to the hand assembly of each wing structure. See *Figure 2*.

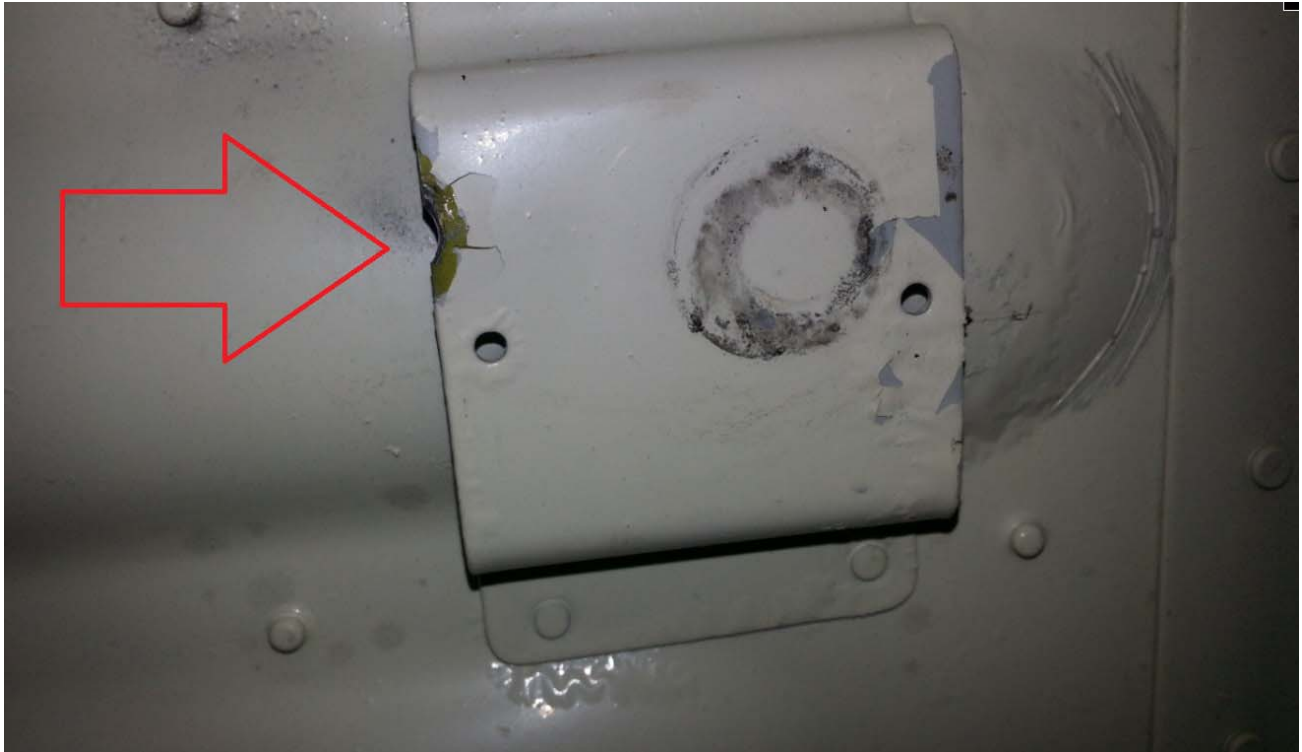
Here is a picture of the results of the exposed threads wearing into the MLG Up-Stop Bracket:

Figure 3 - MLG Up-Stop Bracket Wear

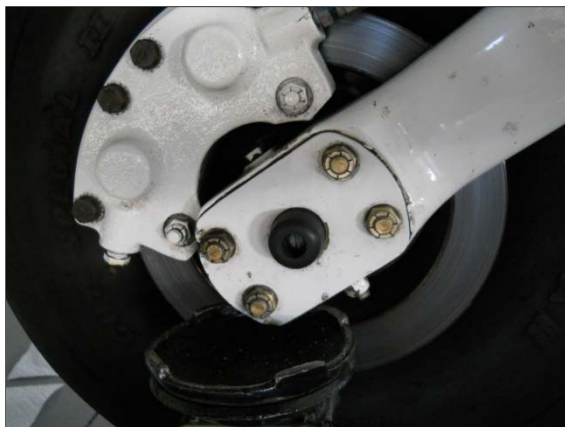
yoke plate. It is believed that well intentioned AP mechanics may have reversed the bolts on some aircraft (so the nuts face the inside of the yoke) to make changing the rubber bumpers a less time consuming task. It is not uncommon for A&P's to want bolts installed in a way that the nut is available for inspection, but in this particular application the nut on the same side as the bumper sets up a condition where the bolt threads can potentially eat into the Up-Stop Bracket and eventually catch on the edge of the plate. Because the hydraulic system exerts substantial force in raising the gear, the binding created can be sufficient to hold up the weight of the gear assembly when trying to lower the gear.

Figure 4 - Incorrect

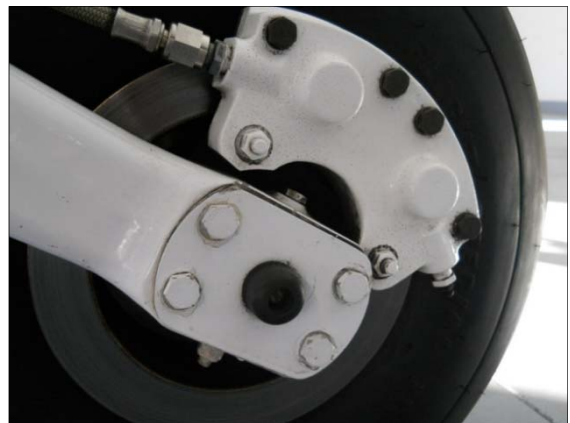
Figure 5 - Correct

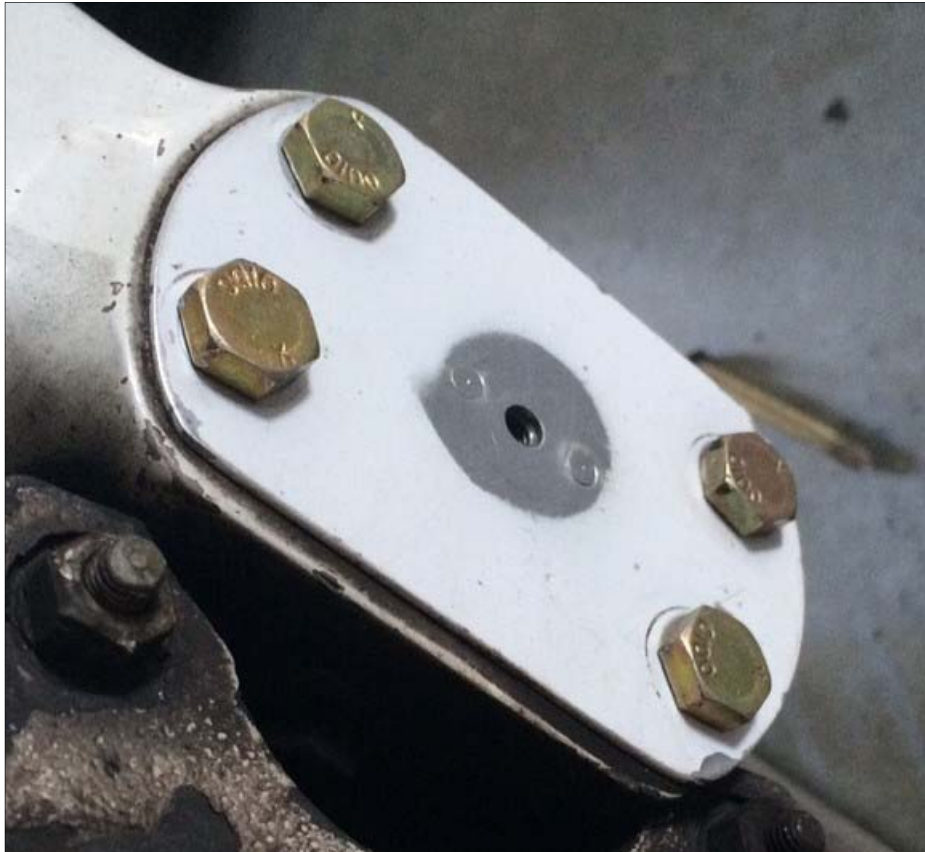
Figure 6

In 1999, the Commander factory recognized the desirability of a solution to allow quick changing of the rubber bumpers without having to remove the wheel, and created an engineering order which detailed installation of a nut plate to the back side of the bumper mounting plate. See Figure 6.

The COG suggests that you consider this small modification as it not only facilitates servicing the rubber bump stops, but by eliminating the need to remove the wheel and plate, the possibility of installing the attaching bolts incorrectly is removed.

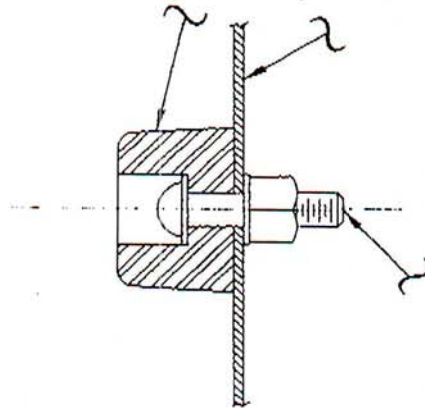
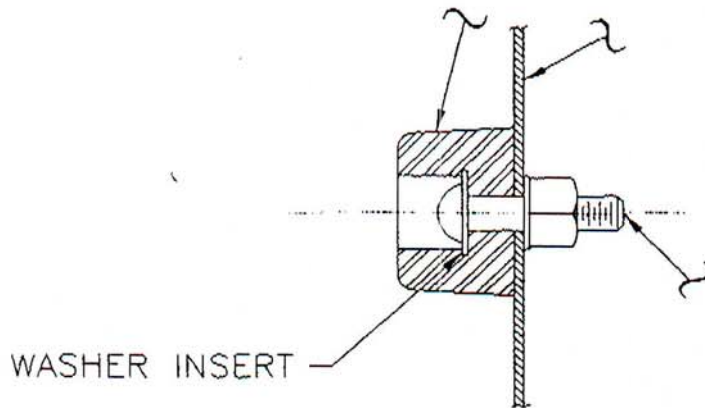
REASON FOR CHANGE: NEED TO CORRECT MAT'L HARDNESS C/O & ADD NEW DASH NO.

3. CHG SEC A-A, WAS:

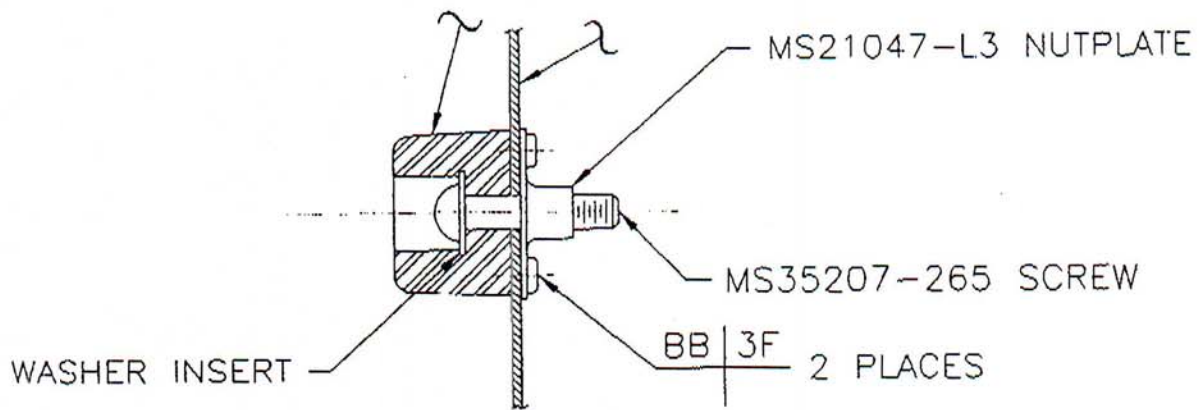
SECTION A-A
 (-501 ONLY)

4. ADD SECOND SEC A-A, S/A SEC A-A EXCEPT AS SHOWN:
